# Strukton Immersion projects

Transport and immersion of 8 caissons

**Chioggia Flood Barrier - Italy**

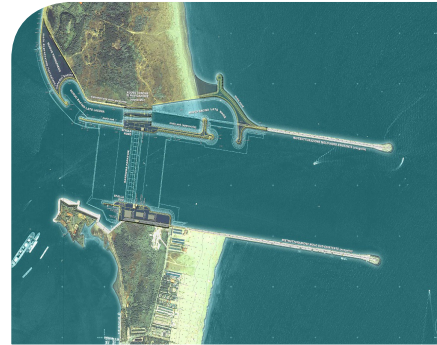
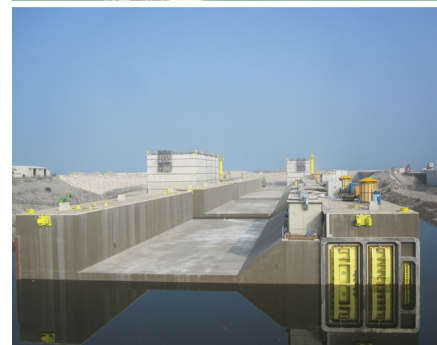
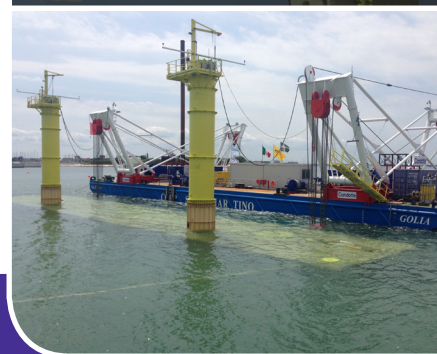
Type:	Caissons for flood barrier
Length immersed section:	400 meters
Total amount of elements:	8
Element measurements:	Gate caissons (LxBxH) = 59,2 x 46 x 11,5m Shoulder caissons (LxBxH) = 24/20 x 60,8 x 24,5m
Depth:	22,5 meters
Achieved placing tolerances:	Vertical: +/- 10 mm, horizontal: +/- 10 mm
Foundation:	Grout bags

The eight caissons were built in a dry dock at approximately 500m from the trench, two shoulder caissons and six gate caissons. The caissons were floated up one by one and moored near the dock gate for the immersion preparations.

The gate caissons creating the middle part of the barrier were immersed with a pontoon. Because currents and waves had a big influence on the immersion system, model test were done to determine the loads and the behaviour of the system. Together with the wave and weather forecast system of the client, safe decisions could be taken to start the immersion operations.

The two shoulder caissons were placed at both ends of the barrier and remain partly above water thus creating access to the caissons for inspection and maintenance. The immersion of the shoulder caissons was done by filling the fifteen ballast clusters step by step. A guiding structure mounted on the quay wall kept the caissons in a controlled position.

All caissons were placed on temporary support pads using a jacking system. The remaining space underneath the caissons was filled by grout injection. During the immersion operation and the grouting works, shipping was blocked for 48 hours.

A special item for this project was the extremely high placing tolerances required for the final working of the gates. At the front side, the caissons were aligned with the previous caisson using a guiding system. At the rear end realignment was done using a jacking system between the caisson and the cofferdam wall of the immersion trench. Extra attention was required for the eccentrically placed immersion joint.
