Chioggia Flood Barrier Italy

Transport and immersion of 8 caissons

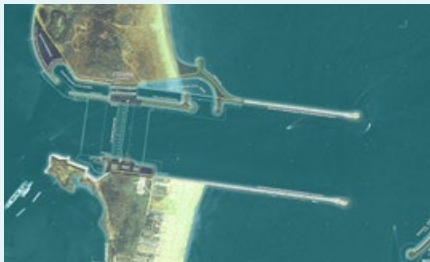
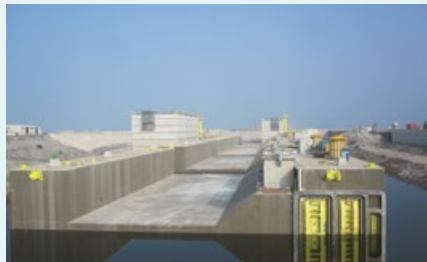
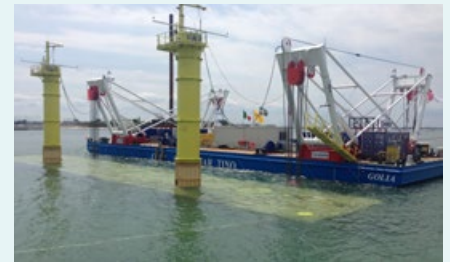
Type:	Caissons for flood barrier
Length immersed section:	400 meters
Total amount of elements:	8
Element measurements:	Gate caissons (LxBxH) = 59,2 x 46 x 11,5m Shoulder caissons (LxBxH) = 24/20 x 60,8 x 24,5m
Depth:	22,5 meters
Achieved placing tolerances:	Vertical: +/- 10 mm, horizontal: +/- 10 mm
Foundation:	Grout bags
